Manhole Inspection Summary

Manhole # S21GG_028MH

Insp Date: **6/14/07 1:06 PM**

Location Address: **1840 PRESSTMAN ST**

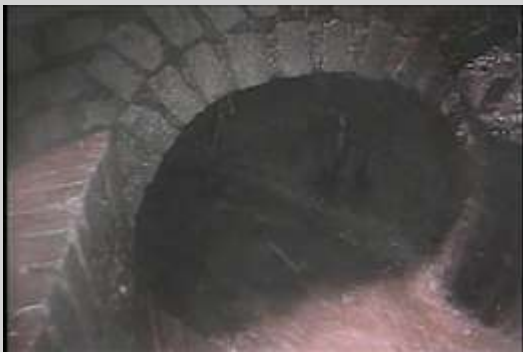
12 O'Clock Outflow

24 in. Circular Gravity Sewer
Pipe Out @ 12 O'Clock

Pipe Height: **24** (in.) Rod and Bar (Angled)
Pipe Material: **Clay** ☐ Pipe Lined
Invert Depth: **18.99** (ft.) Flow Characteristics: **Fast**
Deposits: ☒ None ☐ Mud ☐ Sludge ☐ Debris ☐ Grease
Silt Depth: (in.) Deposits Extent:
Infiltration: **None** Pipe Seal Cond: **Sound**

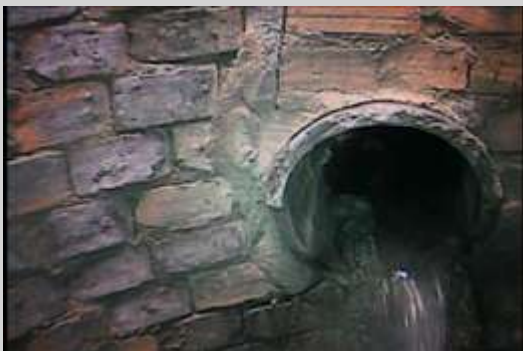
2 O'Clock Inflow

8 in. Circular Gravity Sewer
Pipe In @ 2 O'Clock

Pipe Height: **9.6** (in.) Rod and Bar (Angled)
Pipe Material: **Clay** ☐ Pipe Lined
Invert Depth: **7.39** (ft.) Flow Characteristics: **Slow**
Deposits: ☒ None ☐ Mud ☐ Sludge ☐ Debris ☐ Grease
Silt Depth: (in.) Deposits Extent:
Infiltration: **None** Pipe Seal Cond: **Sound**

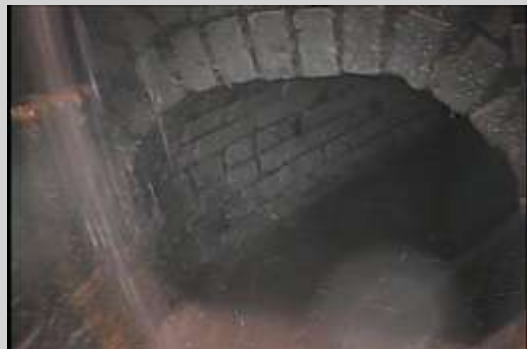
7 O'Clock Inflow

24 in. Circular Gravity Sewer

Pipe In @ 7 O'Clock

Pipe Height: **24** (in.) Rod and Bar (Angled)

Pipe Material: **Clay** ☐ Pipe Lined

Infiltration: **None** Pipe Seal Cond: **Sound**
